Contract #: 04-0120F4Cty: SF/ALA Rte: 80 PM: 13.2/13.9File #: 13.28**WELDING INSPECTION REPORT****Resident Engineer:**Pursell, Gary**Address:** 333 Burma Road**City:** Oakland, CA 94607**Report No:** WIR-006415**Date Inspected:** 27-Apr-2009**Project Name:** SAS Superstructure**OSM Arrival Time:** 1400**Prime Contractor:** American Bridge/Fluor Enterprises, a JV**OSM Departure Time:** 2230**Contractor:** Oregon Iron Works Clackamas, Or.**Location:** Clackamas, OR**CWI Name:** Steve Barnett**CWI Present:** Yes No**Inspected CWI report:** Yes No N/A**Rod Oven in Use:** Yes No N/A**Electrode to specification:** Yes No N/A**Weld Procedures Followed:** Yes No N/A**Qualified Welders:** Yes No N/A**Verified Joint Fit-up:** Yes No N/A**Approved Drawings:** Yes No N/A**Approved WPS:** Yes No N/A**Delayed / Cancelled:** Yes No N/A**Bridge No:** 34-0006**Component:** Hinge-K Components**Summary of Items Observed:**

Summary of Items Observed: On this date, Caltrans Quality Assurance Inspector (QA) Clete Henke was present at Oregon Iron Works, Inc. (OIW) in Clackamas, OR for observation of fabrication of the Hinge K Pipe Beams and related activities including in process welding and OIW Quality

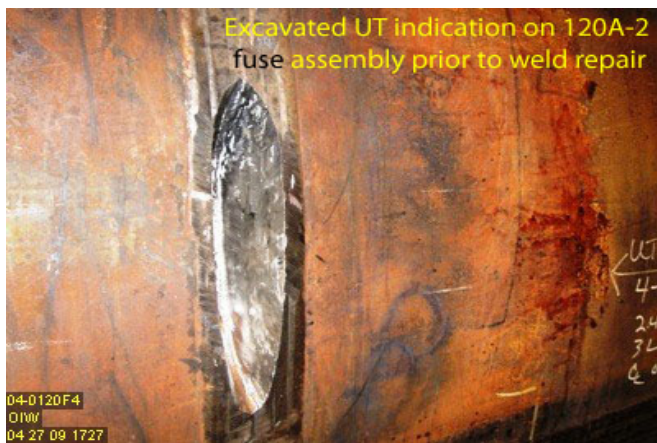
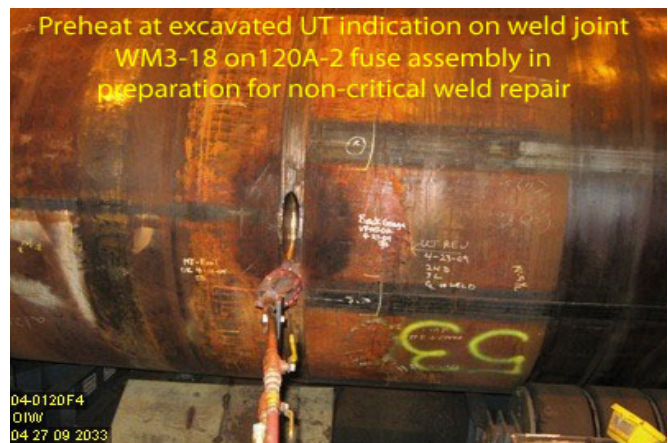
The QA Inspector intermittently monitored OIW welder Yuriy Bannikov (WID B61) during completion of Submerged Arc Welding (SAW) at weld joint WM3-12 joining a125 stiffener ring to a124-13 Fuse Section.

Welder B61 deposited SAW fill and cover passes in the flat (1G) position in accordance with approved welding procedure 4020. With completion of WM3-12, Fuse Section a124-13 stiffener ring connections were complete.

The QA Inspector observed as OIW QC Inspector Steve Barnett performed Magnetic particle Testing (MT) and Visual Inspection (VT) of completed cover passes at welds WM3-12 through WM3-17. Mr. Barnett stated that he had located no rejectable indications. The QA Inspector subsequently performed 100% VT at the locations noted above finding the completed welds to be in general compliance with contract documents. The QA Inspector noted that OIW personnel removed Fuse section a124-13 from the welding fixture and replaced it with a124-2. Preheat was initiated on a124-2 shortly before the end of the shift.

The QA Inspector was notified by OIW QC Inspector Steve Barnett that QC Magnetic particle Testing (MT) and Visual Inspection (VT) had been completed on a124-4 Fuse Section with no rejectable indications located. The QA Inspector subsequently performed 100% VT of completed cover passes at welds WM3-02 through WM3-11, finding the completed welds to be in general compliance with contract documents.

The QA Inspector noted that one rejectable indication located during preliminary Ultrasonic Testing (UT) on circumferential CJP weld WM3-18 had been excavated during day shift. The QA Inspector intermittently observed as OIW welder Bui Liem (WID B10) ground the excavated area in an attempt to create a weldable profile. OIW QC Inspector Steve Barnett performed Magnetic particle Testing (MT) at the completed excavation, locating no rejectable indications. Welder B10 had initiated preheat at the affected area shortly before the end of the shift. The QA Inspector noted that OIW QC Inspector Steve Barnett was regularly monitoring and recording in-progress preheat as welder B10 brought the area up to temperature.
